# Hallett

## Troubleshooting Guide.

## Hallett 500,750,1000

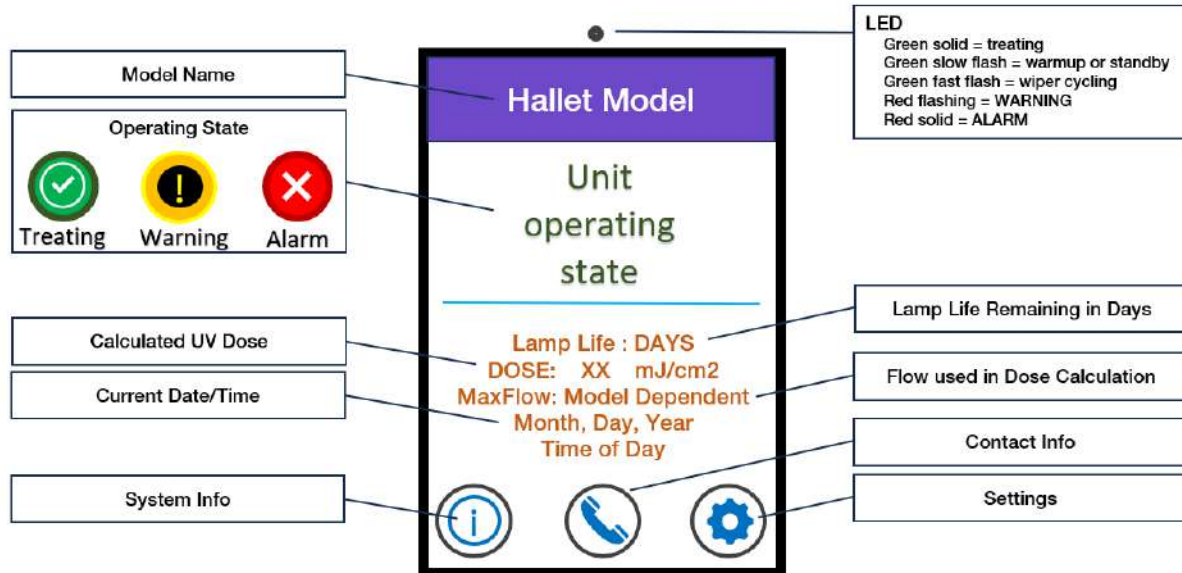
Touch the display screen to wake it

From the main display screen, record the current UV Dose, UVI and UVT values

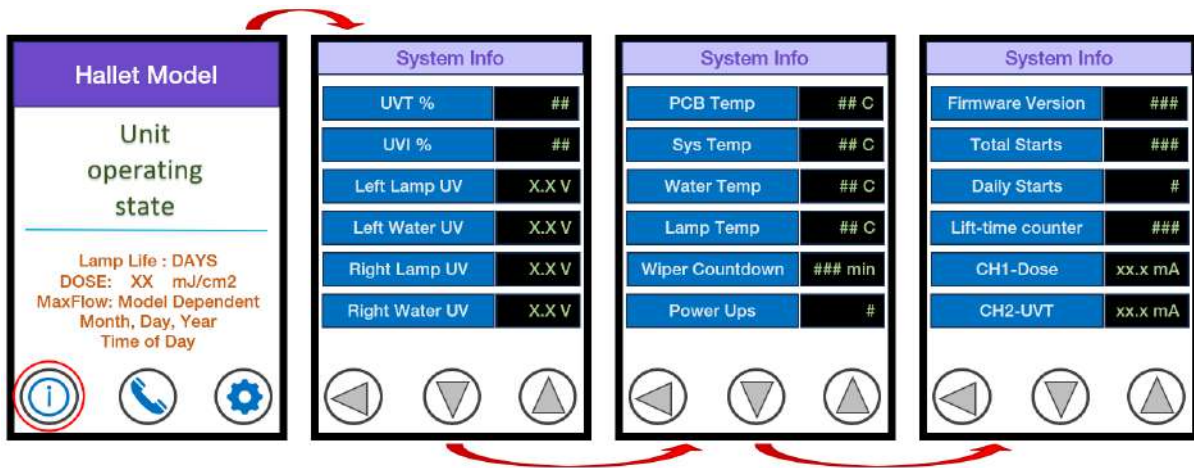
Record the values

1. Record the total lamp starts.
2. Total Starts
3. Power Ups
4. Lifetime counter
5. Check the unit message history.

Two of the most useful parameters for troubleshooting, seen on the first page of the System Info, are the UV Transmittance (UVT) and UV Intensity (UVI) values.

The UV sensor values are also provided on the first page. Further, more detailed sensor information is provided in the Force Output menus.

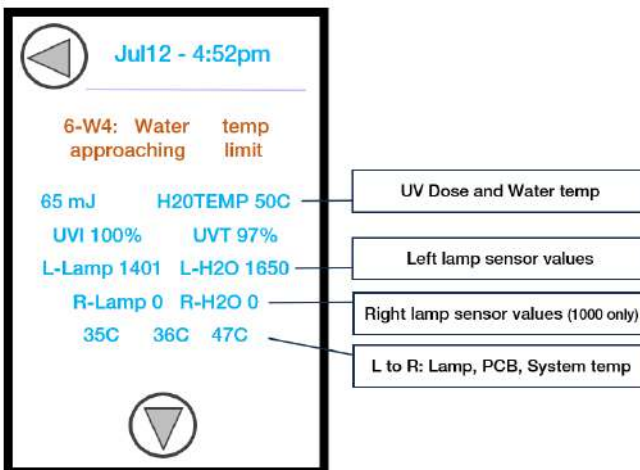
When a warning or alarm has occurred, the Hallett unit records the incident in the Message History located in the Settings Menu

Touch the message of interest to view details

In addition to recording which warning or alarm occurred, the unit will record the date and the time, the UV dose, the UVI, the UVT, the UV sensor values in mV, and various temperatures.

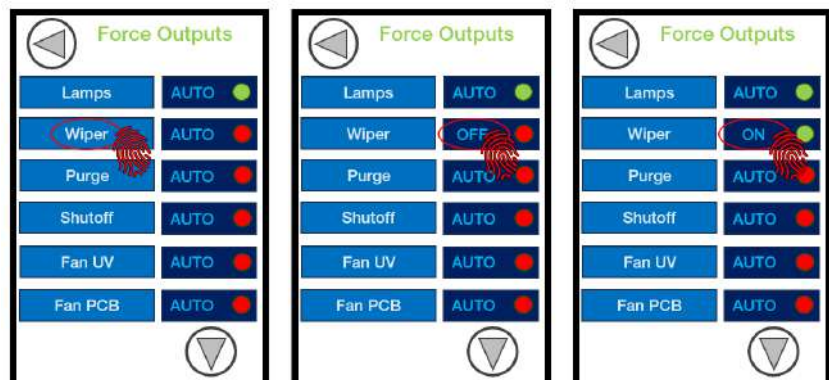
First, tap the name of the output you wish to activate

Next tap the operational state to switch between ON, OFF or AUTO. The colour of the indicator will change depending whether the device is active or not.

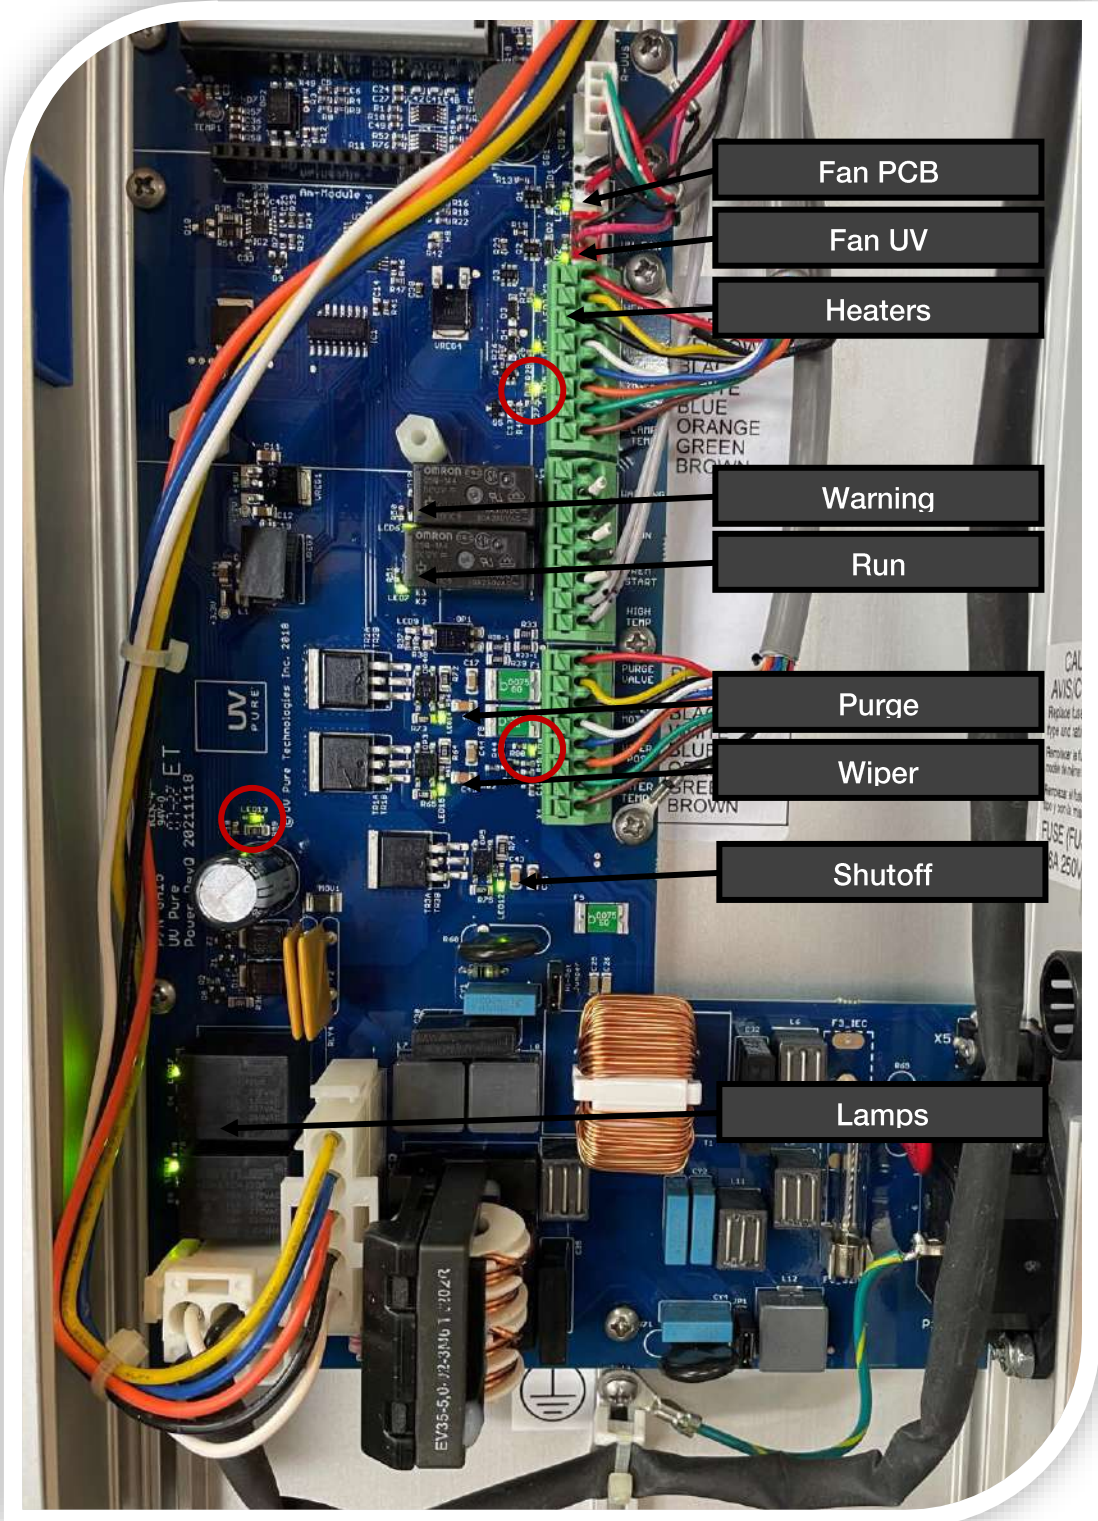
On the power board, are a number of LED's which illuminate when the circuit is active

The three LED's circled in red should be permanently on

If the LED's come on when the output is forced, you can also check for the voltage at the relevant device connection This ensures the PCB is functional and supplying power to the Device.

If the LEDs don't illuminate and no voltage is present, then the issue is with the PCB.

Note if one of these LEDs is not illuminated, it's possible the LED itself could be defective so using a multi-meter, you can measure 230V (or 120V) across the wires of the ballast input power connectors BAL1 & BAL2. This will confirm that power is being delivered to the ballasts.

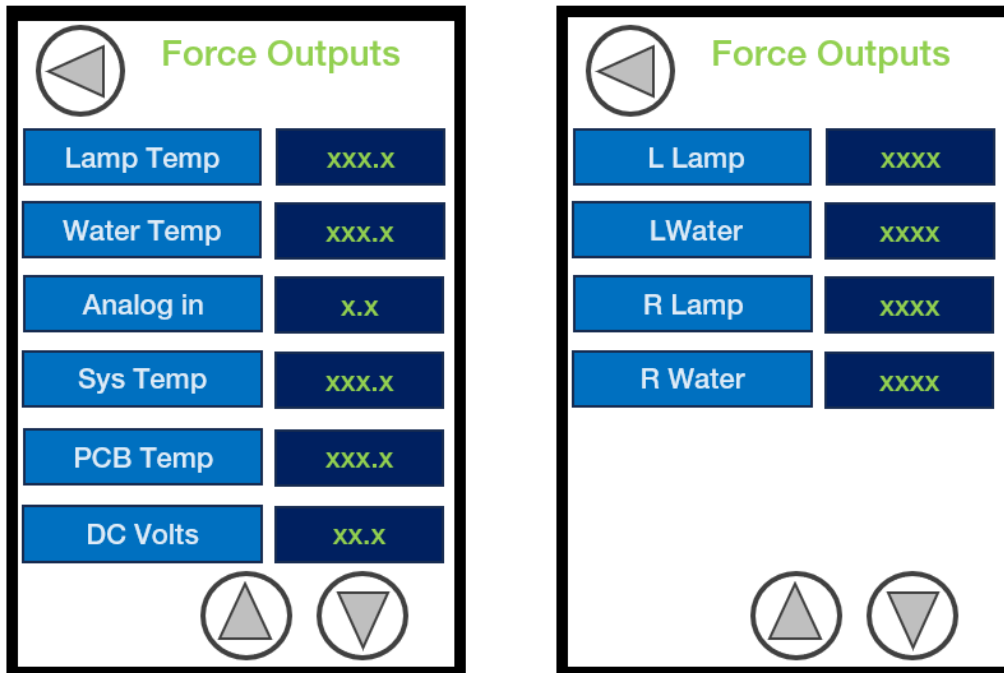
## Force Outputs Menu - Pages 4 and 5

The 4<sup>th</sup> and 5<sup>th</sup> screens in the force outputs menu provides greater detail and accuracy than that which can be seen in the System Info menu.

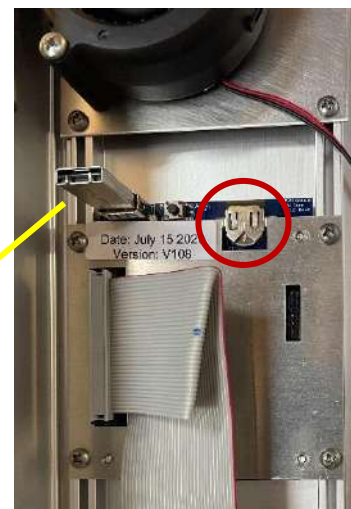
The Real-Time clock is powered by a coin battery locked on the back of the LCD touchscreen.

If the date and time is lost every time the power is cycled, replace battery (3V CR1220).

Fitting a USB stick for manual data logging is strongly encouraged.  
Maximum length 20mm

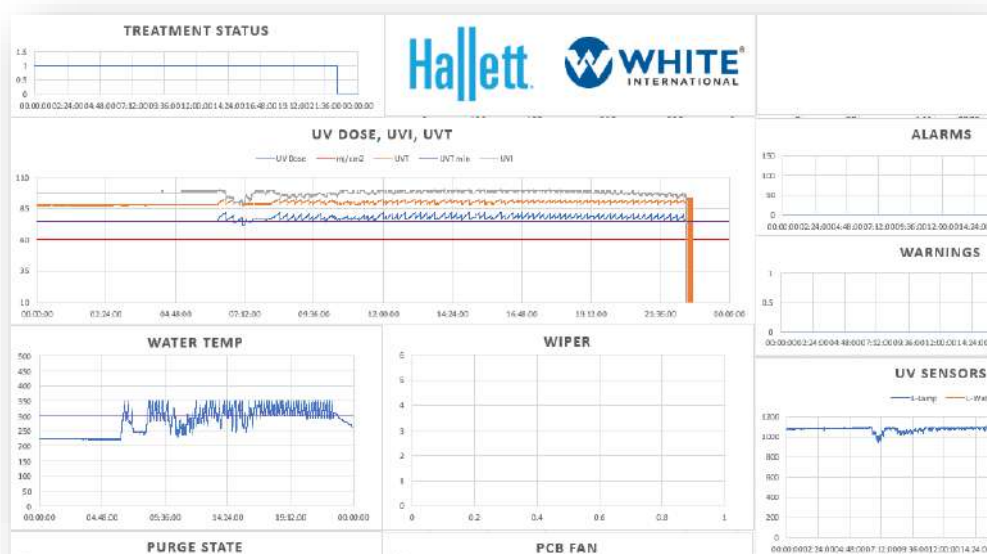
By analysing the data the possible causes can be identified accurately and quickly.

Contact White International for assistance with log file analysis
